**GENERAL**

Form Type INITIAL - Assembly / Annual

Crane Number CR1217

Crane Model Number LR11000

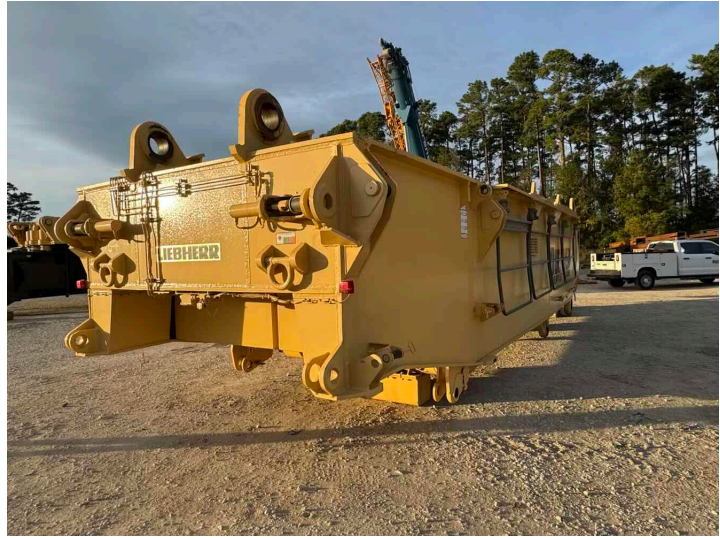
Photo 1

Q7: What is the current Paint Condition and Corrosion Control?

Touch-up / Rust

Some scrapes, scratches, rust, faded paint off color paint etc. Much hydraulic and old absorbing towels under spot for W2, crane dirty.

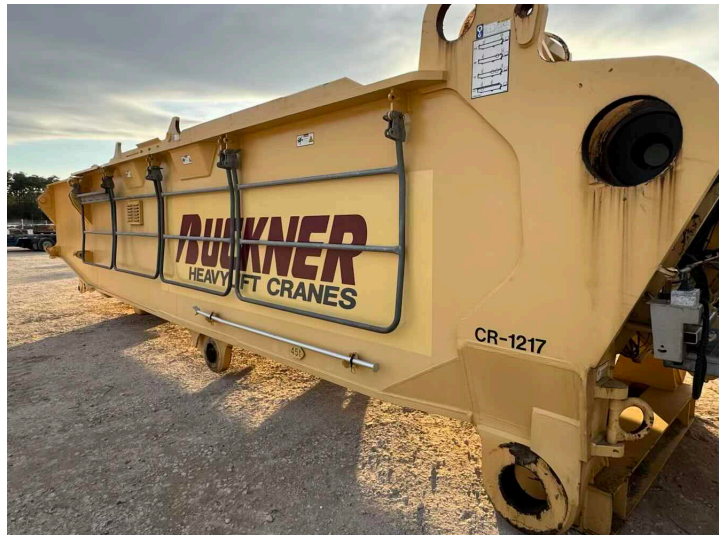
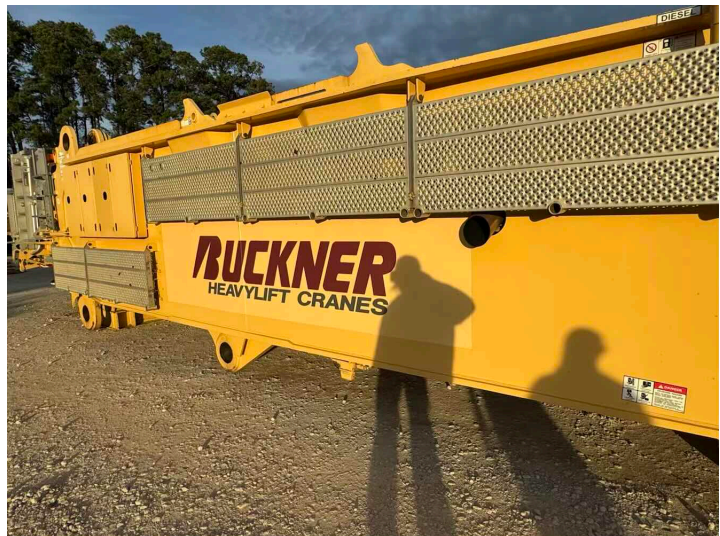
Q10: Are Buckner Heavylift Company Decals present on the machine and in good condition?

Off color.

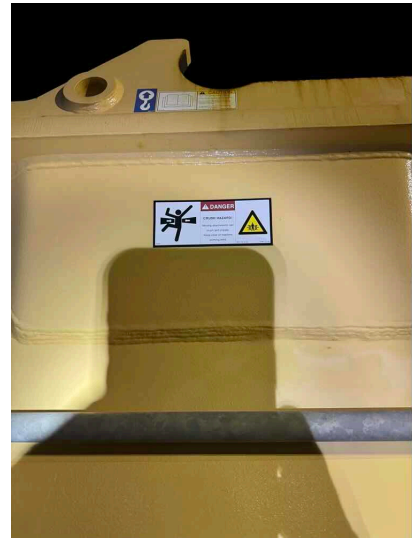
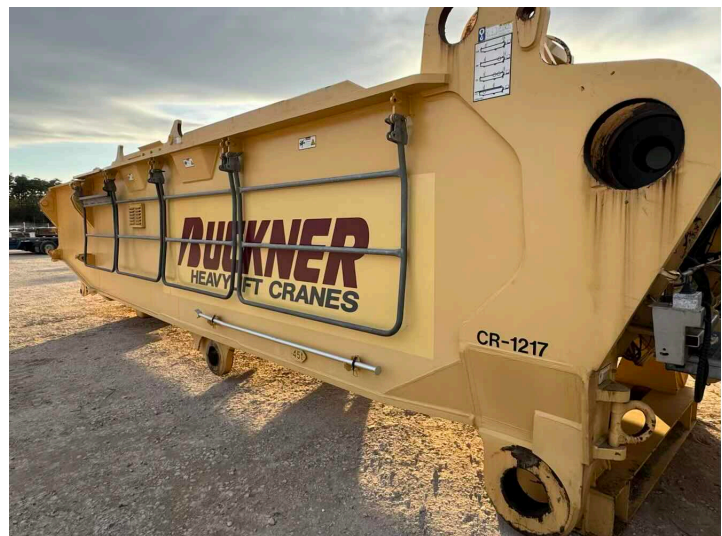
Q12: Are all the originally supplied and required Safety / Warning Decals and Labels present in a good and legible condition?

Present.

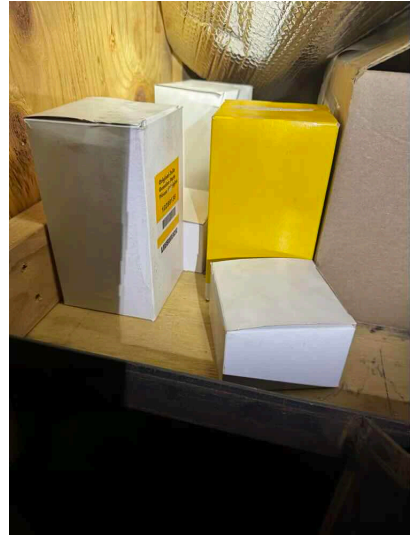
Photo 1

Q15: Are there spare Fuel Filters present in the Crane  
Conex / Box and are they sealed and in good condition?

Present.

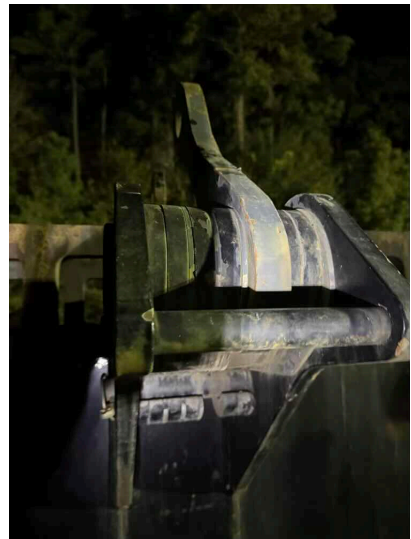
Photo 1

Q6: Are the Track Frame Lifting Lugs (Dog Bone) free of deformation, cracks, significantly corroded members, loose fasteners, cracked welds, evidence of heating, or significant wear?

No deficiencies observed during inspection.

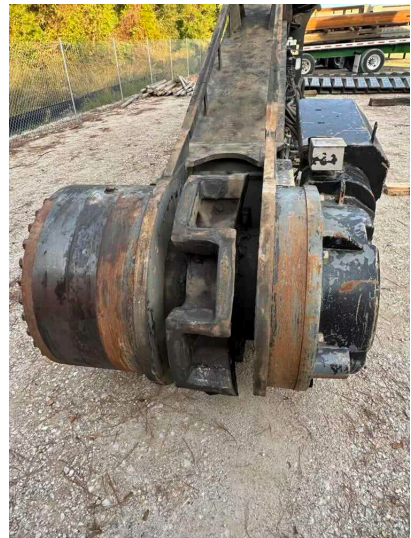
Photo 1

Q8: Are the Drive Sprockets, Drive Chain, and Drive Tumblers free of excessive wear?

No excessive wear observed.

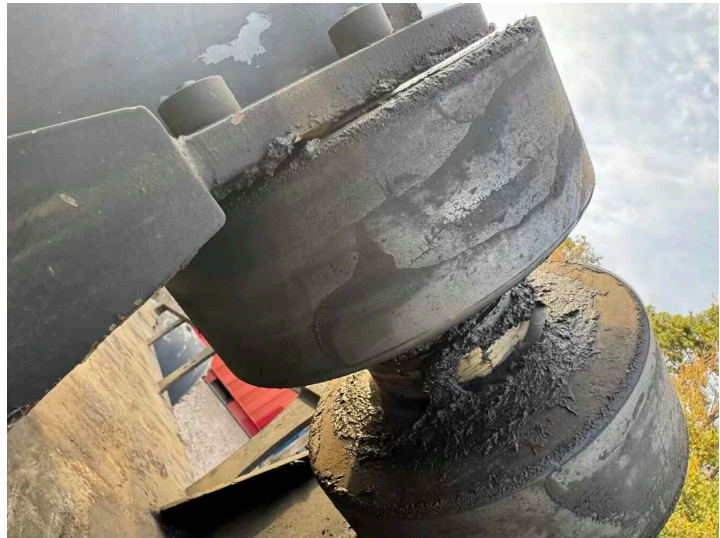
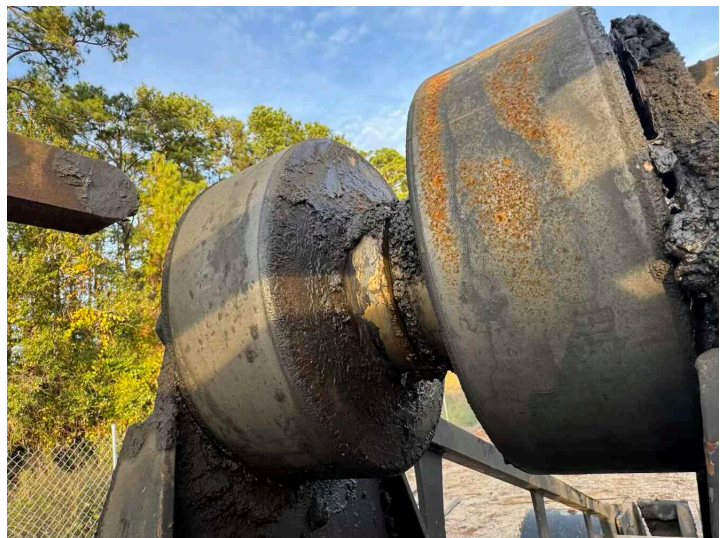
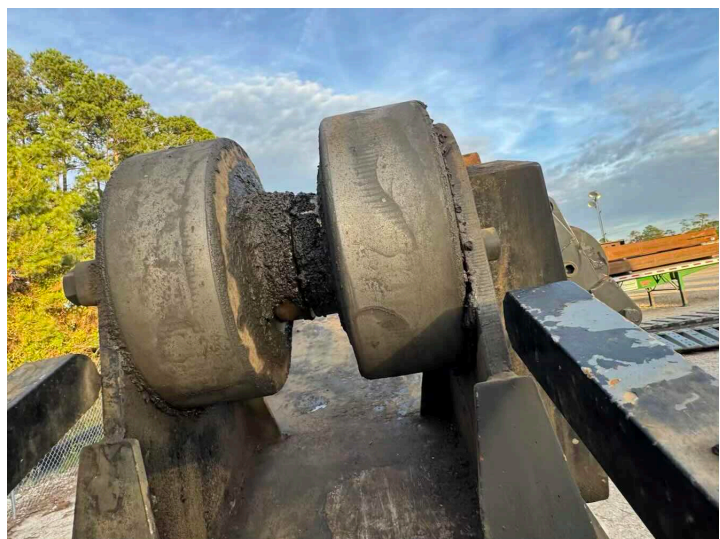
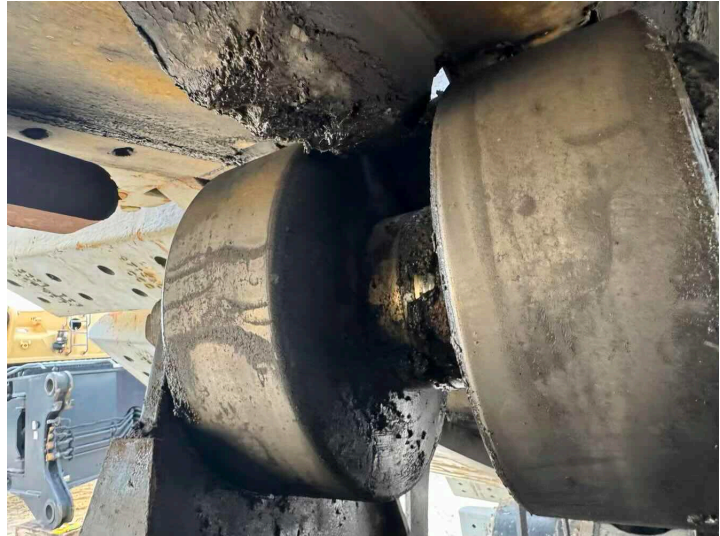
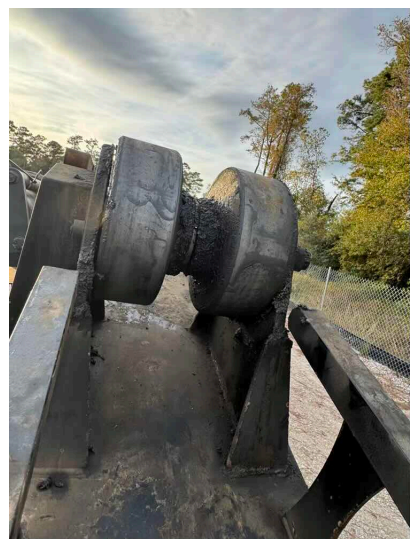
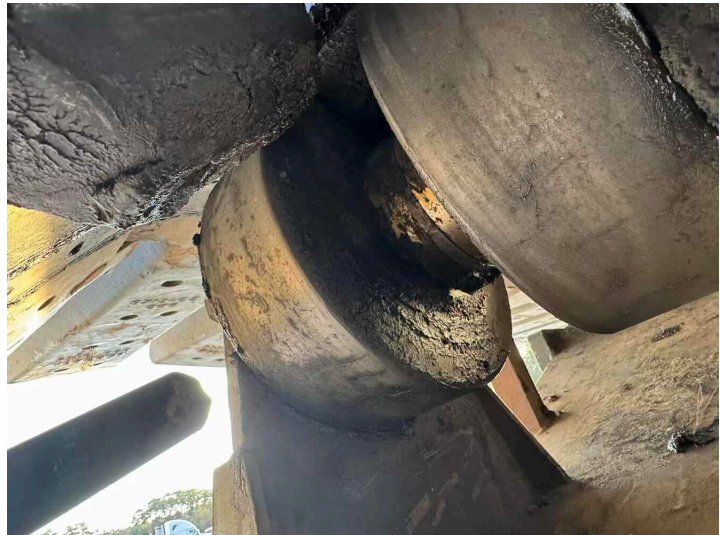
Q10: Are the Sprockets, Idlers, and Rollers free of excessive wear?

No deficiencies observed during inspection.

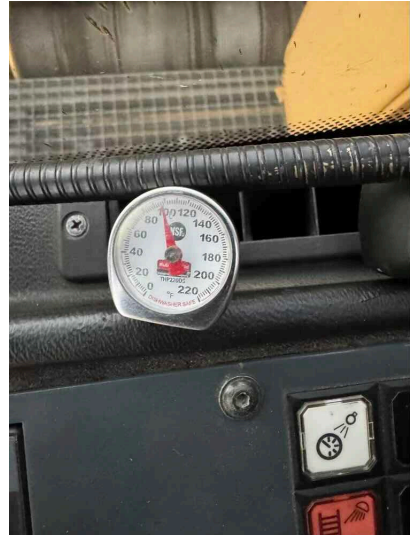
Photo 1

Functioning properly.

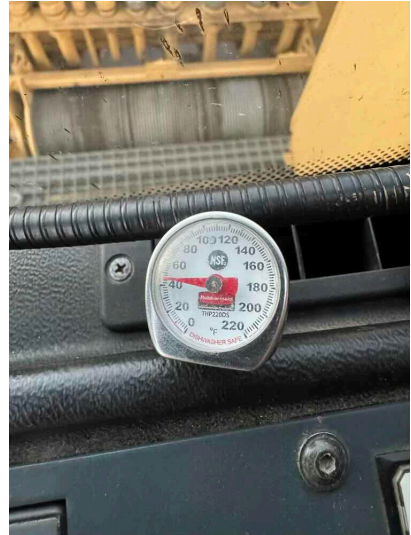
Photo 1

Q10: Is the Air Conditioner in an operational condition?

Functioning properly.

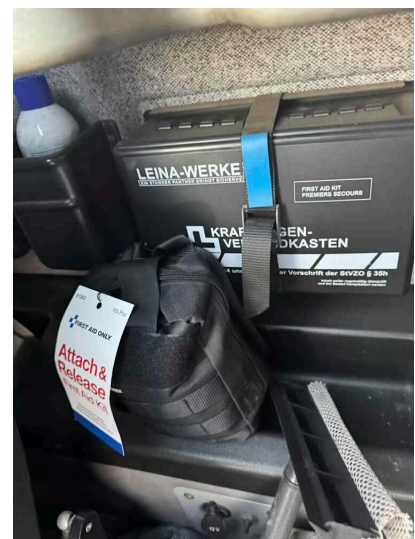
Photo 1

Present.

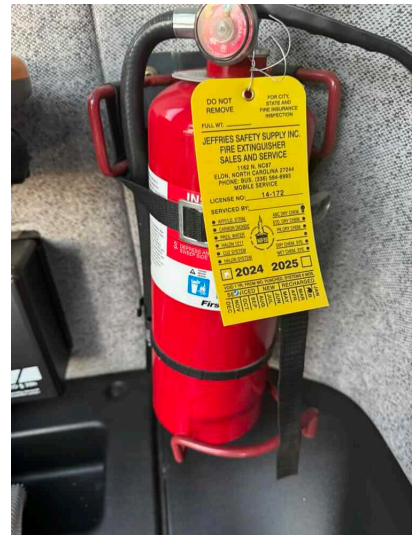
Photo 1

Q14: Is the Fire Extinguisher present, in a safe operating condition, and free of apparent damage that could cause failure during its use?

Present.

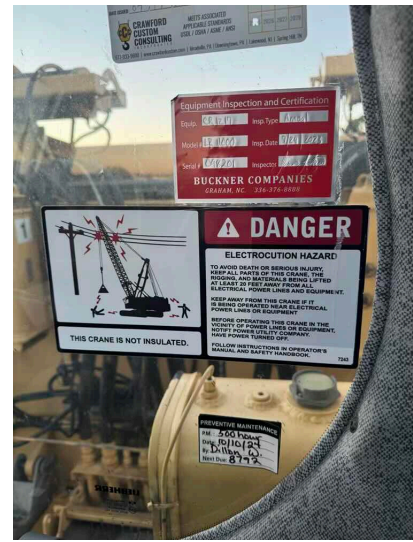
Photo 1

Q22: Are all the originally supplied and required Safety / Warning Decals and Labels present in a good and legible condition?

Present.

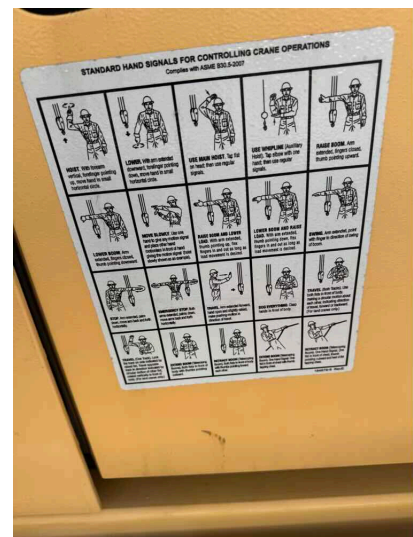
Photo 1

Q24: Is there a Hand Signal Chart posted on the Crane in a good and legible condition? YES

Present.

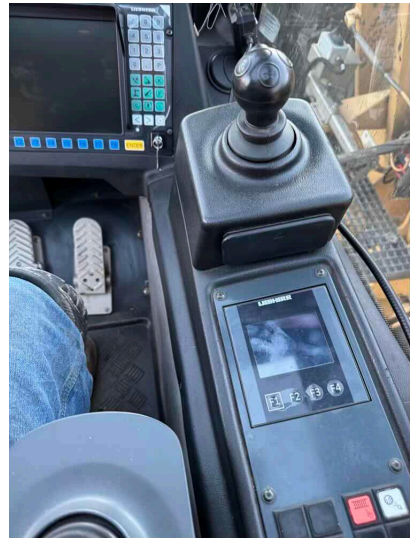
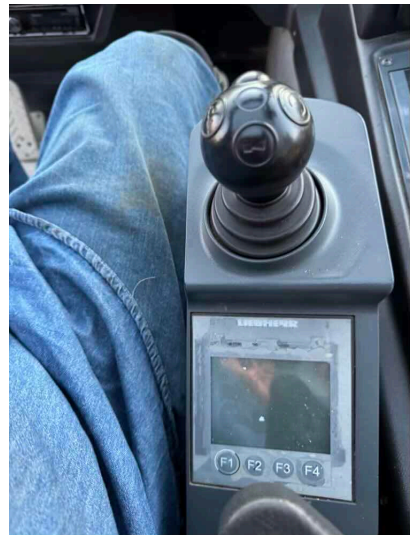
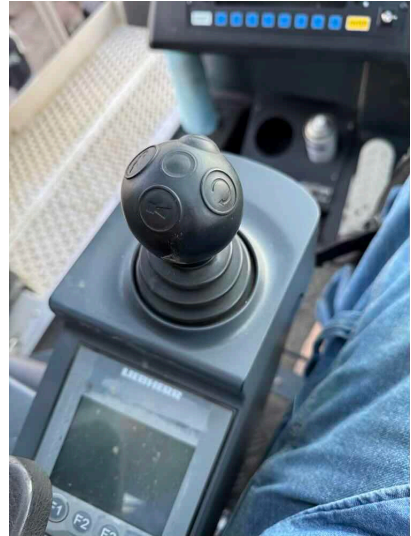
Q28: Are the Operating Control Handle Rubber Boots without dry-rot, rips, tears, or holes which would allow entry of dirt and contaminants into the control.

No deficiencies observed.

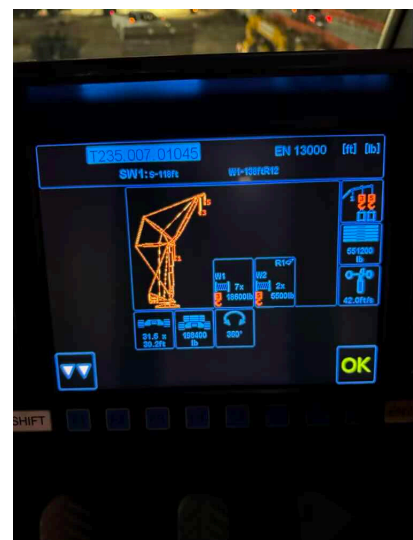
Photo 1

Configuration per load chart.

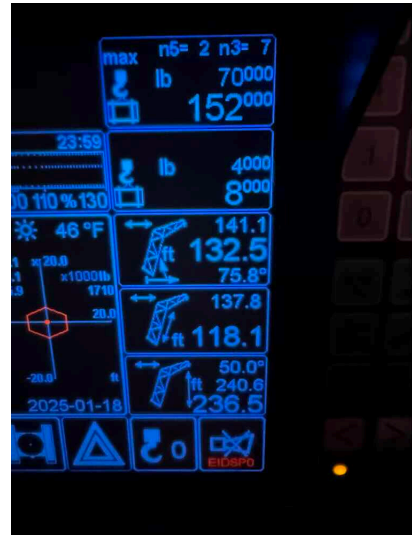
Photo 1

Q8: Does the Load Weight Indicator function properly?

Functioning properly.

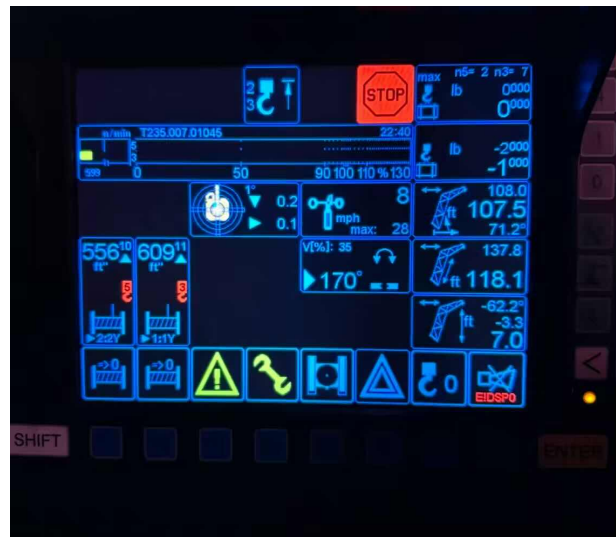
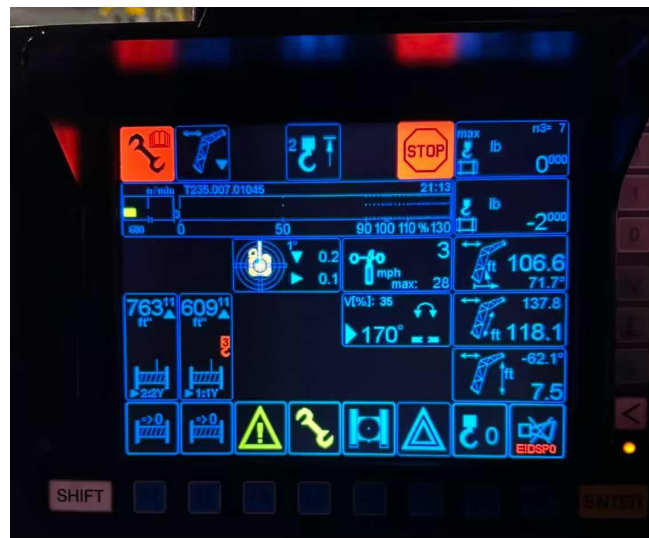
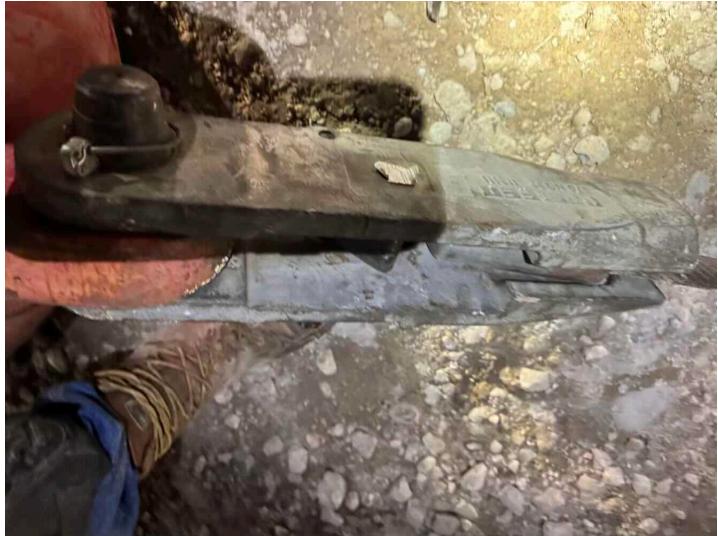
Q11: Does the Anti-Two Block Device(s) (A2B) function properly?

Main and auxiliary function tested good.

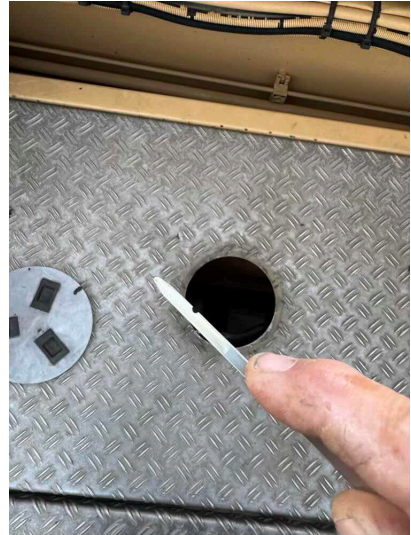
Photo 1

Full.

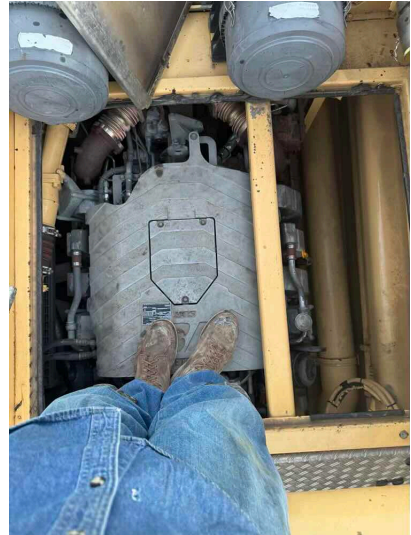
Photo 1

Q3: Is the Engine free of any engine oil leaks?

No deficiencies observed.

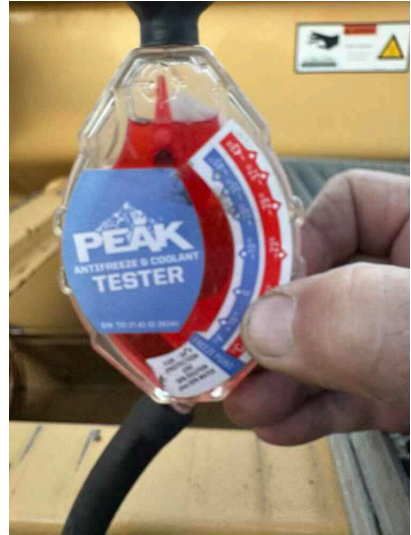
Photo 1

Q4: Is the Antifreeze level full and at the proper level?

No deficiencies observed. Boiling point 131° Freezing point -45°

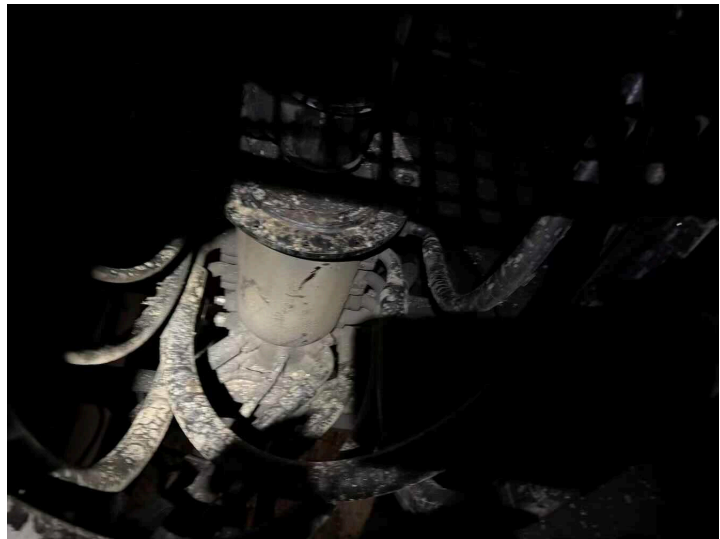
Photo 1

Q11: Does the Electrical / Hydraulic Swivel appear free of leaks, damage, deterioration, corrosion, and dirt and moisture accumulation that would affect its proper operation?

Very dirty lots of grease and hydraulic oil.

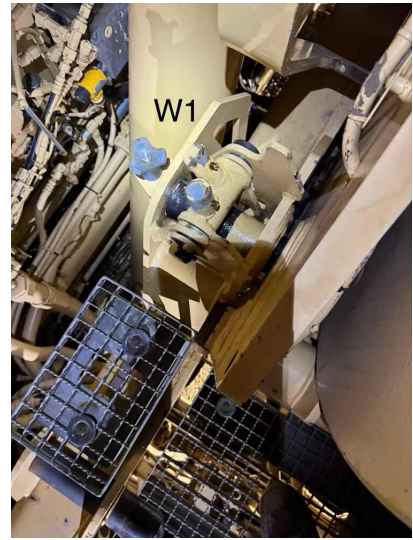
Photo 1

Q12: Is the Main Winch properly installed in the Upperworks and are the mounting fasteners without issue?

Properly installed and secured.

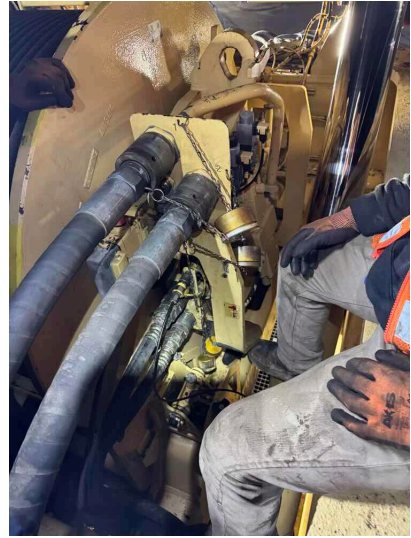
Photo 1

Q13: Is the Main Winch hydraulic motor, lines, hoses, valves, and connections free of leakage, damage, or chaffing?

No deficiencies observed.

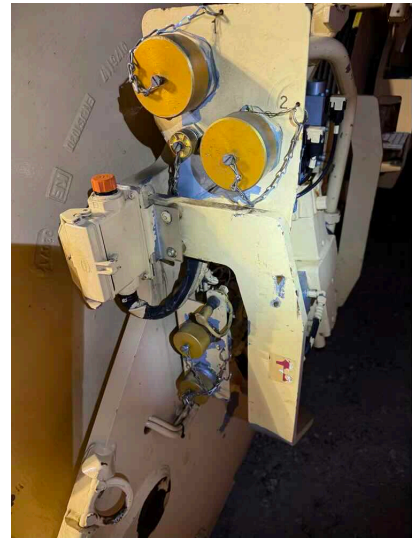
Photo 1

Q16: Are the Main Winch Hydraulic QD Caps / Plugs present and attached to the Hydraulic lines on the Winch, so they don't get damaged or lost? YES

Present.

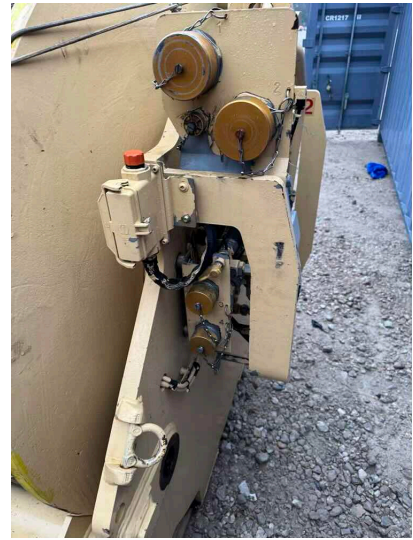
Photo 1

Q27: Are the Aux Winch Hydraulic QD Caps / Plugs present and attached to the Hydraulic lines on the Winch, so they don't get damaged or lost? YES

Present.

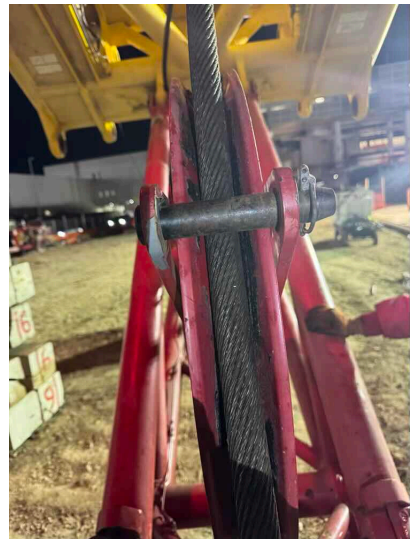
Photo 1

Q33: Is the Auxiliary Hoist Reeving according to manufacturer specifications and without kinking, crushing, unstranding, birdcaging, signs of core failure, and steel core protrusion between the outer strands?

Single part.

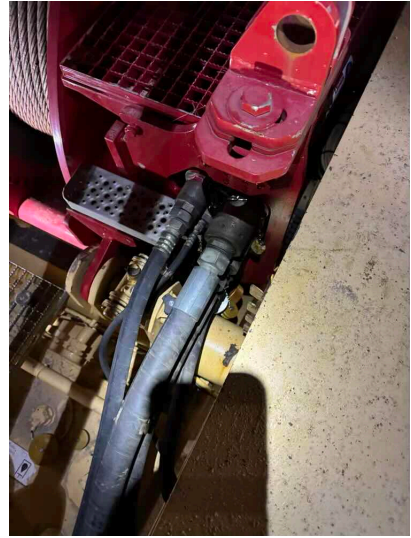
Photo 1

No deficiencies observed.

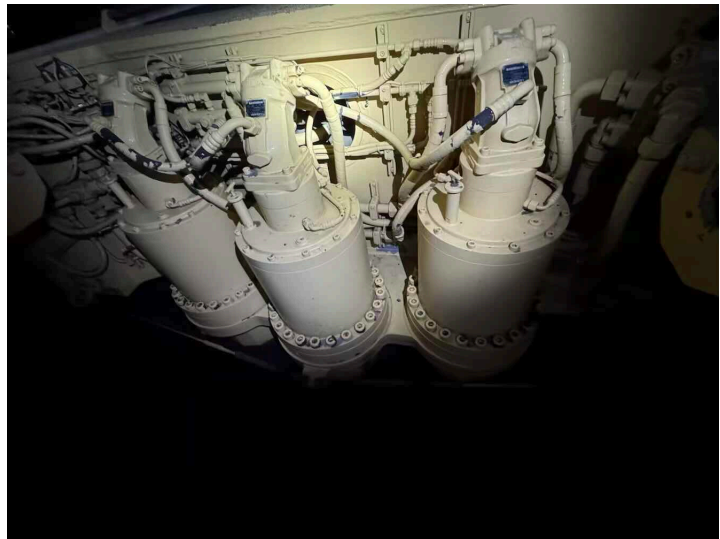
Photo 1

Q46: Is the Swing System, Swing Assembly, Swing Drives, Swing Motors, and Swing Gear Box free of unusual noise, excessive overheating, loose bolts, and full of oil?

Swing motors 1,2,and 3 at low mark.

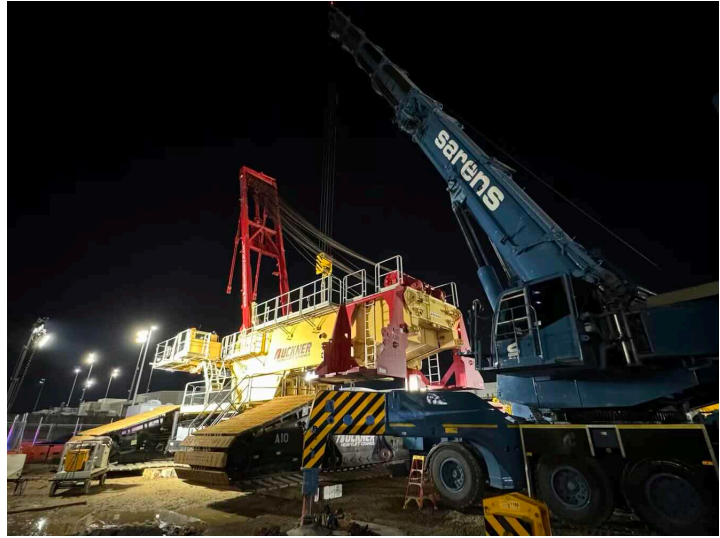
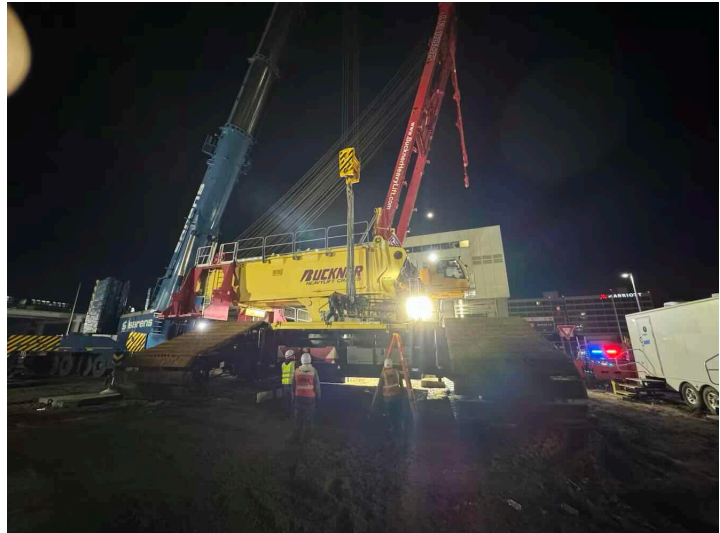
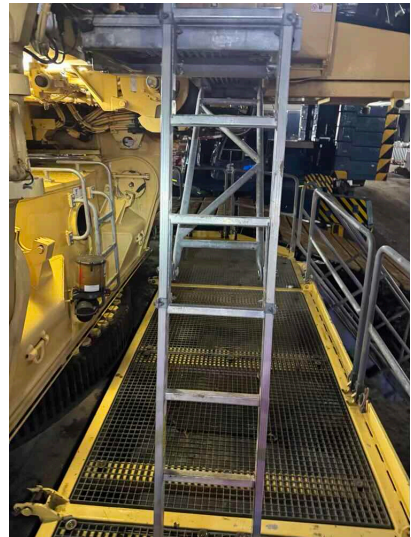
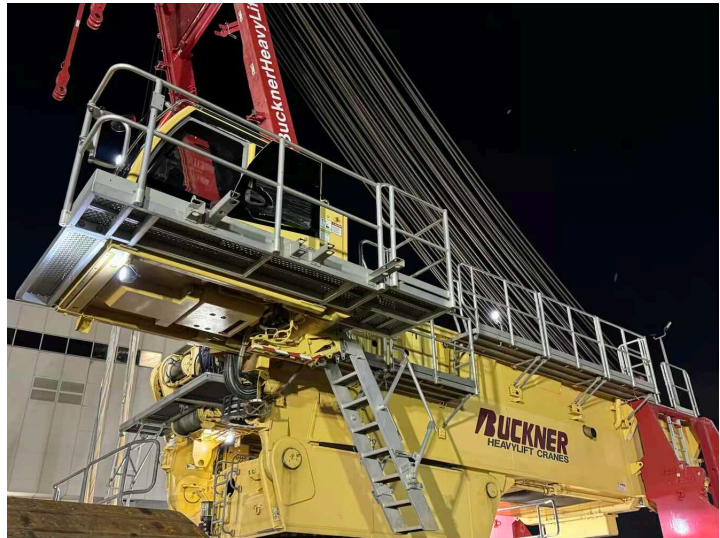
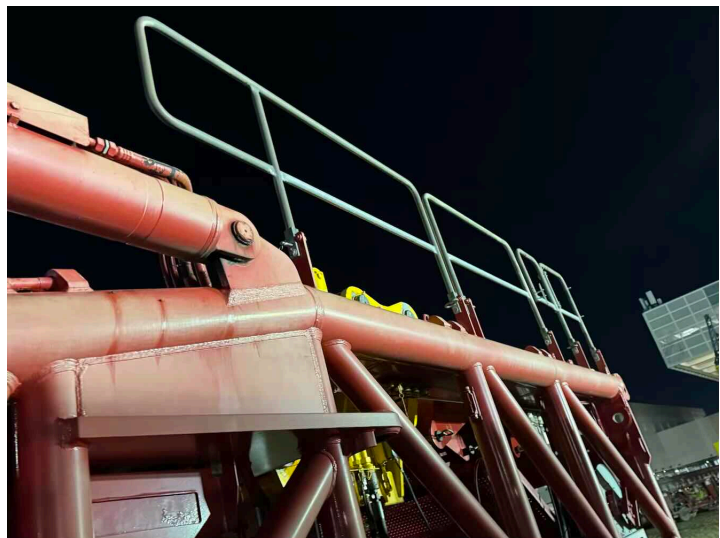
Q53: Are the Steps, Ladders, Handrails, and Guards used to access the Cab and Upper Works present and in a safe and usable condition?

No deficiencies observed.

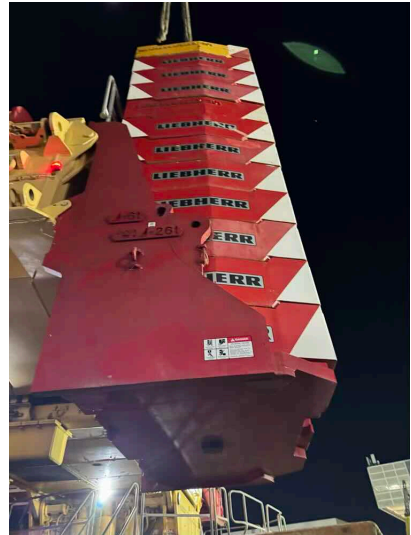
Photo 2

Q55: Is all the Counterweight present, free of cracks, and without issues with the lifting bitts?

No deficiencies observed.

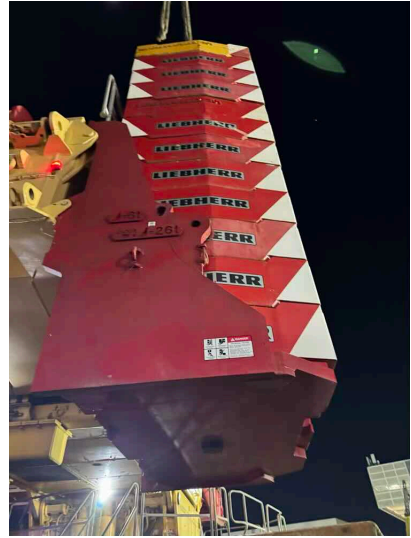
Photo 1

Q57: Are all the originally supplied and required Counterweight Warning Signs present in a good and legible condition?

Installed.

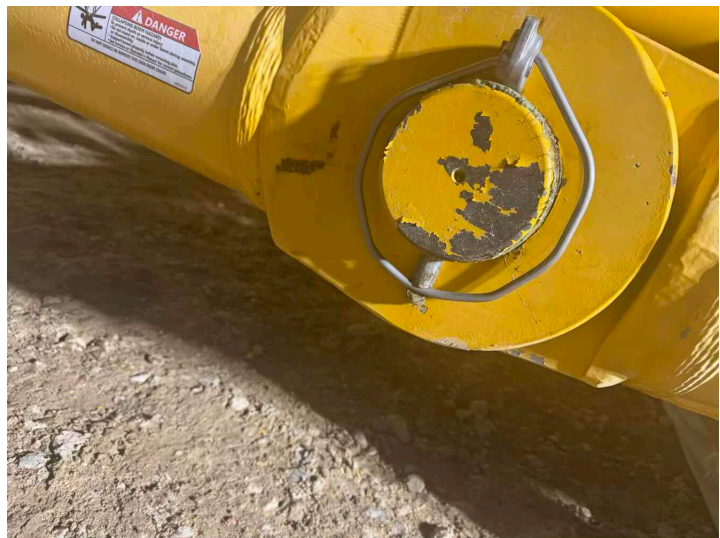
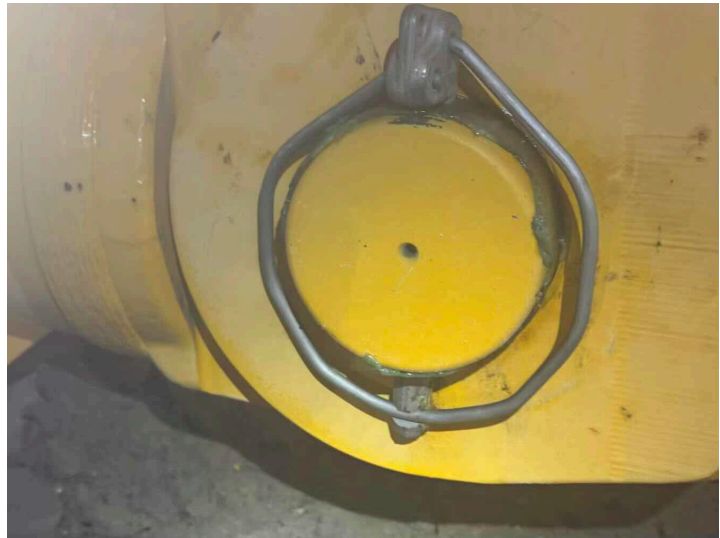
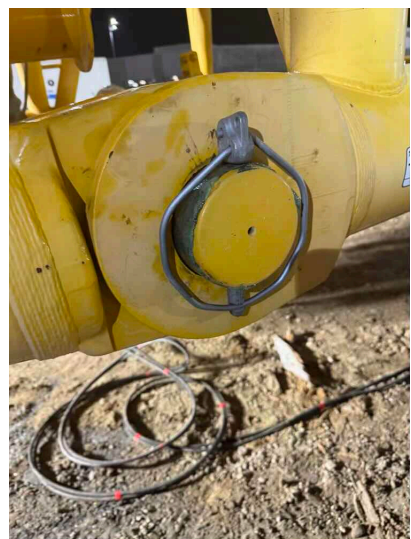
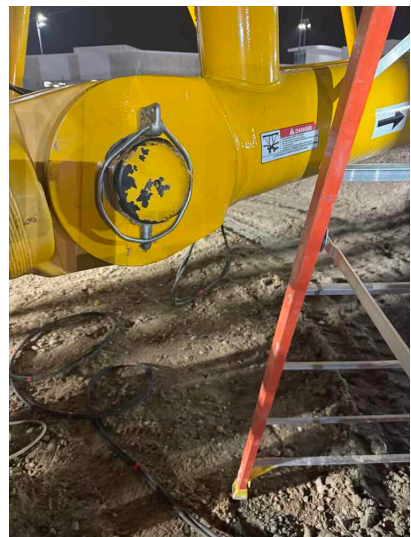
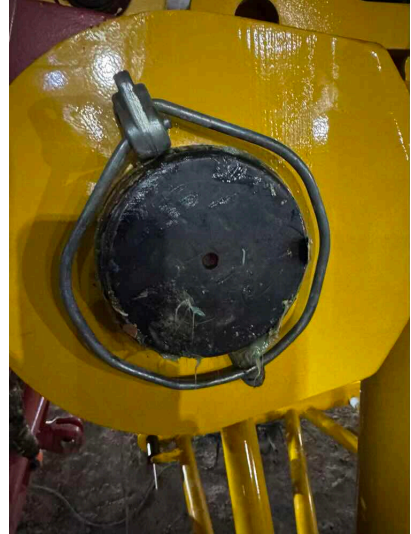
Q4: Are the End Connections, Pins, Pin Retainers, and Push Pins free of deformation, cracks, significantly corroded members, loose fasteners, cracked welds, and significant wear?

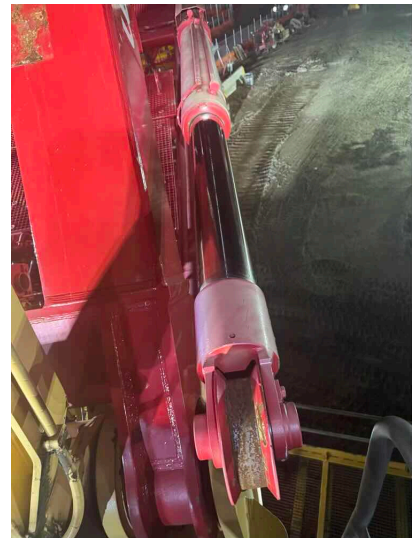
Photo 2

Q9: Are the Boom Stop Cylinders (S Relapse Cylinders) free of deformation, cracks, significantly corroded members, loose fasteners, cracked welds, hydraulic leaks, and significant wear?

No deficiencies observed.

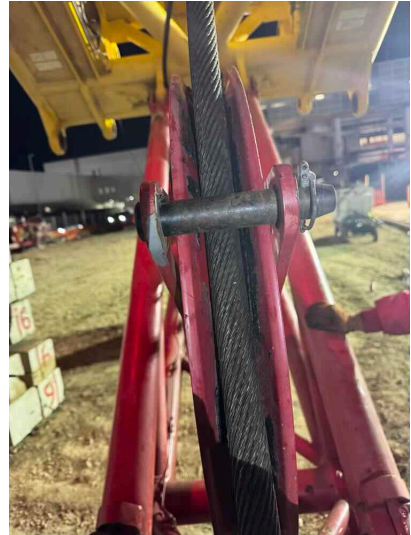
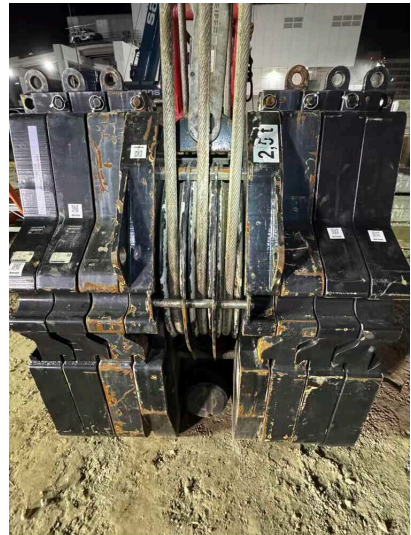
Q17: Are the Wire Rope Retainer(s) present and installed correctly without significant wear?

Properly installed and secured.

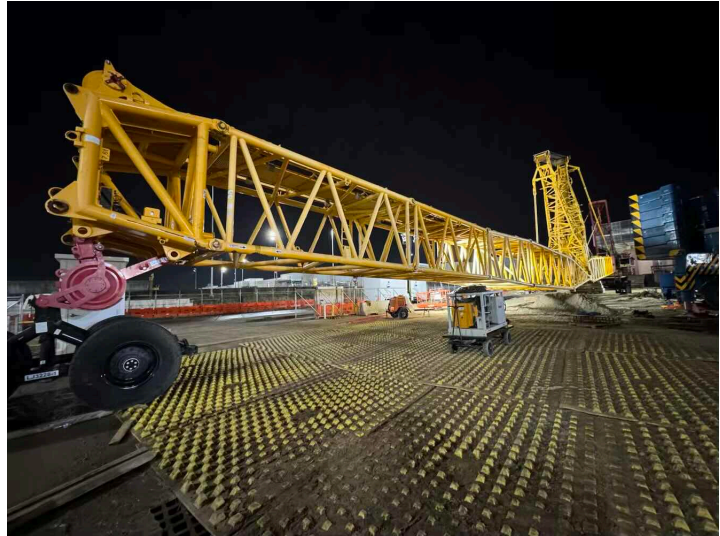
Photo 3

Q1: Are the Lattice Members free of deformation, cracks, significantly corroded members, loose fasteners, cracked welds, and significant wear?

No deficiencies observed during inspection.

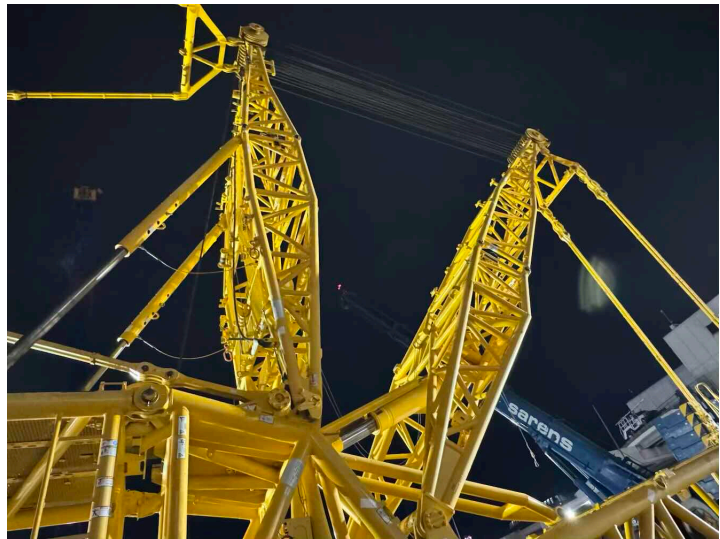
Photo 1

Q4: Is the Jib A-Frame (Queens Post) or WA-Frame 1 and WA-Frame 2 free of deformation, cracks, significantly corroded members, loose fasteners, cracked welds, and significant wear?

No deficiencies observed during inspection.

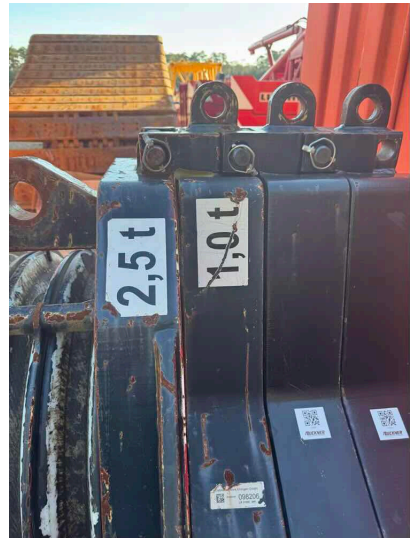
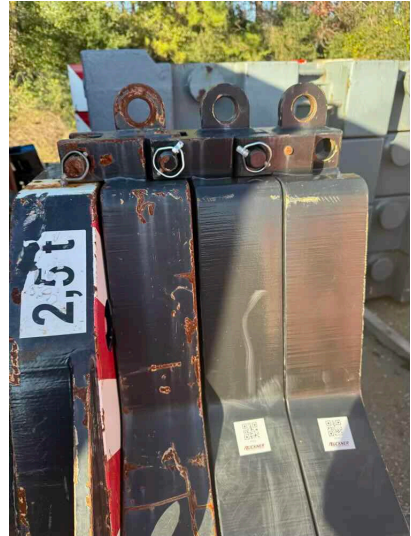
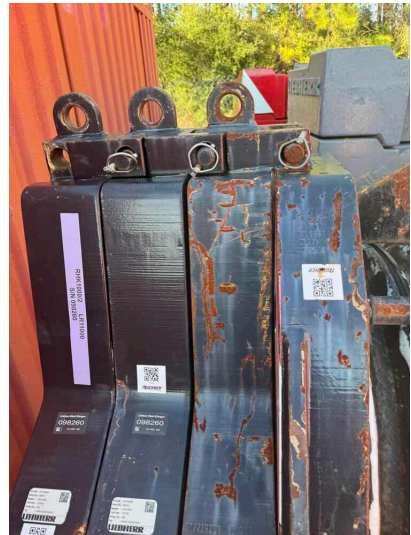
Q7: Are the Cheek Weights free of deformation, cracks, significantly corroded members, loose fasteners, and cracked welds?

No deficiencies observed during inspection, properly secured.

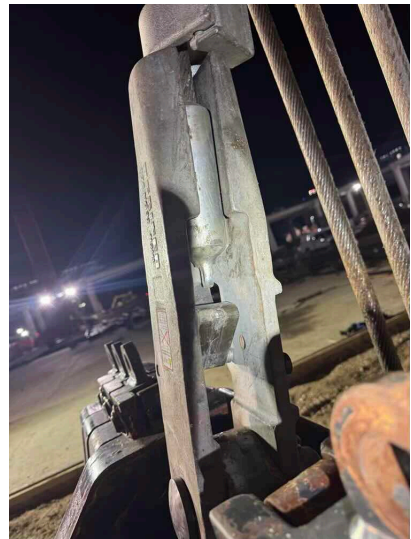
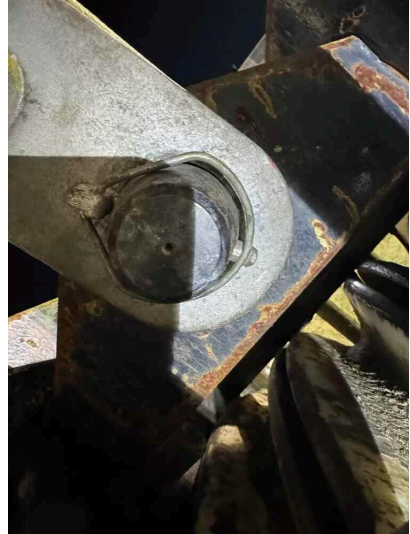
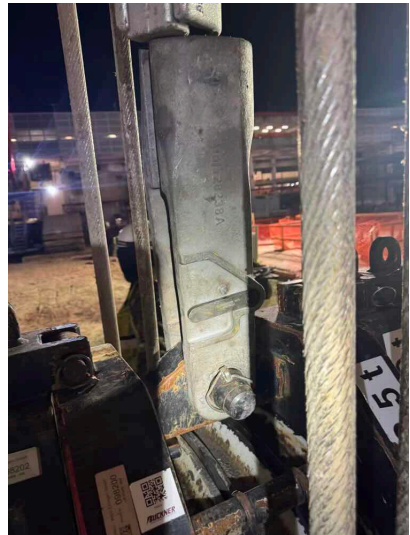
No discrepancies observed.

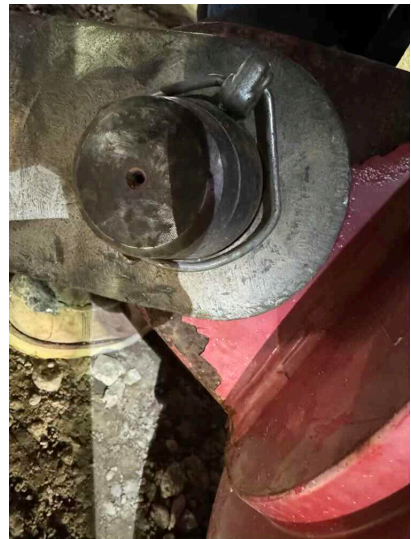
Photo 1

Properly installed and secured, no deficiencies observed.

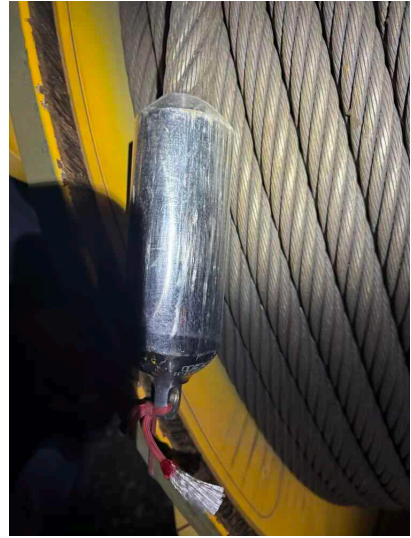
Photo 1

No deficiencies observed during inspection. oil level is full. Hoses good no leaks. Becket properly installed and secured.

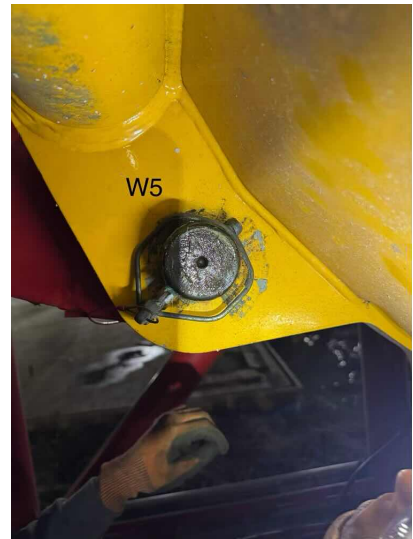
Photo 1

Winch properly installed and secured.  
32.56 by 32.83
